Problem

Customer	Tri-States Power
Type of Machinery	Coal Pulverizer (B&W)
Reservoir Capacity	260 Gal
Operating Fluid	EP 360
Schroeder Product	K9 Duplex Assembly
Customer Problem	OEM wire mesh screen filters were unable to control the ingress of coal dust which was causing degradation wear to internal bearings and gears.

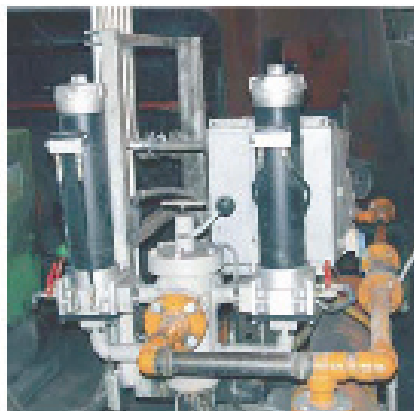
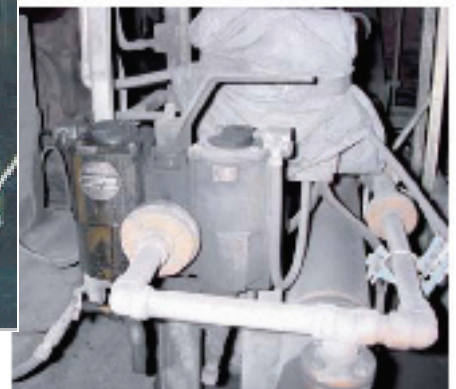
B&W coal pulverizer system OEM supplied filtration was unable to keep up with the ingress of coal dust into the lube oil reservoir causing degradation wear to the bearings and gears.

They removed the wire mesh OEM-supplied filters and installed our K9 duplex assembly with the KZ10 elements, primary and standby housings and realized immediate results of cleaner oil, leading to longer fluid life and elimination of system downtime due to abrasive particulate contamination.

Other cost savings realized include: longer element service life, lower consumption of replacement elements, reduction in start time, and overall reduction in operating costs.
