Problem

Customer	PacifiCorp Power, Naughton Plant, Kemmerer, WY
Type of Machinery	Series 803, Alstom-CE Coal Pulverizers
Reservoir Capacity	255 Gal
Operating Fluid	ISO 460 Synthetic
Schroeder Product	KLD-4021 Kidney Loop Skid
Customer Problem	External Ingression of coal dust getting into the lube oil reservoir causing degradation wear on bearings, bull gears.

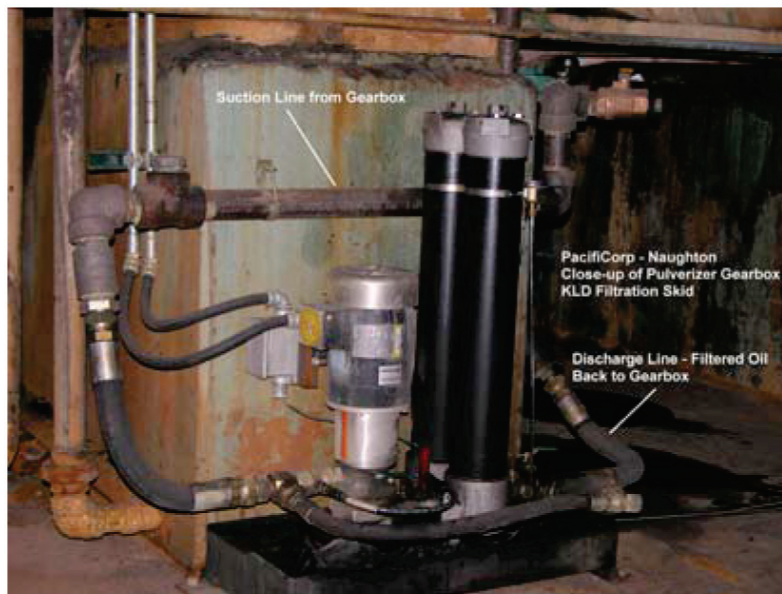
Customer was experiencing problems with external ingress of coal dust getting into the lube oil reservoirs on their coal pulverizers causing degradation wear on the bearings and bull gears, which lead to premature aging of the system components.

We worked with PacifiCorp for a formal beta site test/trial installation which documented that following installation and testing of our KLD-4021 filtration skid, the system was cleaned up and the coal dust particulate was being controlled which helped eliminate the internal wear on system components as well as unscheduled downtime due to contamination.

Customer has upgraded 10 mills to date with 3 more budgeted for completion in 2008.
